approach

SEPTEMBER 1970 THE NAVAL AVIATION SAFETY REVIEW

MIDAIRS

A Continuing Threat

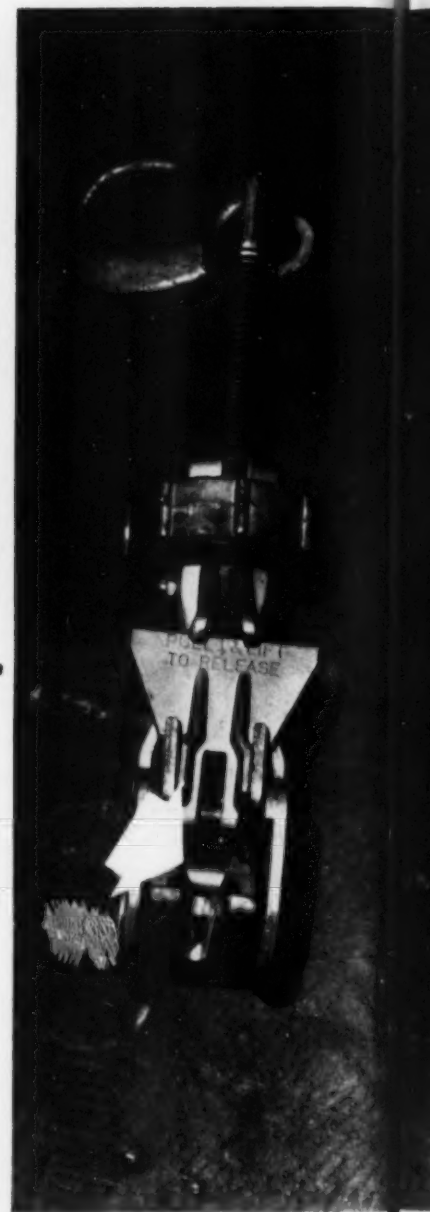
1. Locking pawl missing; chain can be lifted out without releasing butterfly.

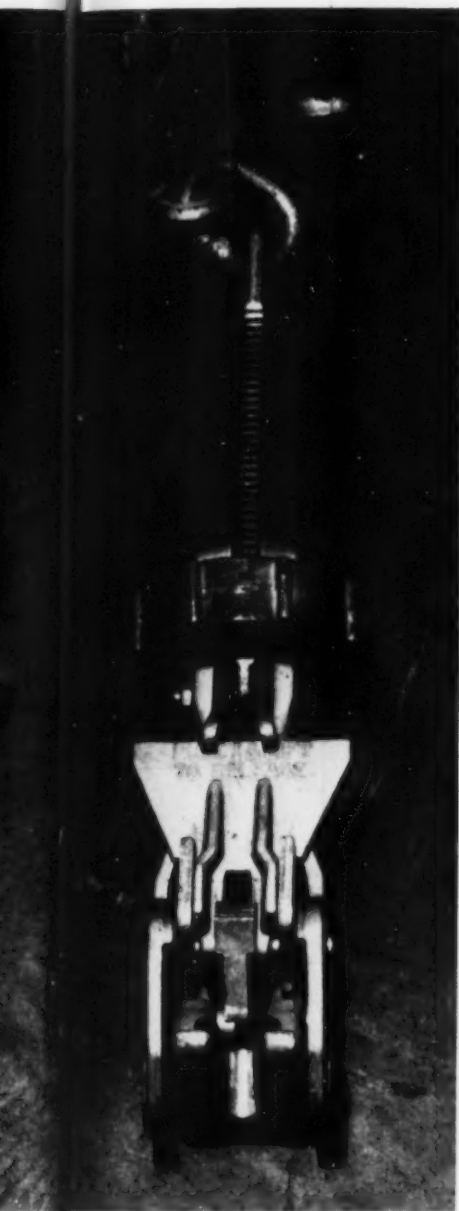
2

2. Nothing wrong here; keep it this way by periodic inspection and repair. Join chain and head with light cable to avoid loss.

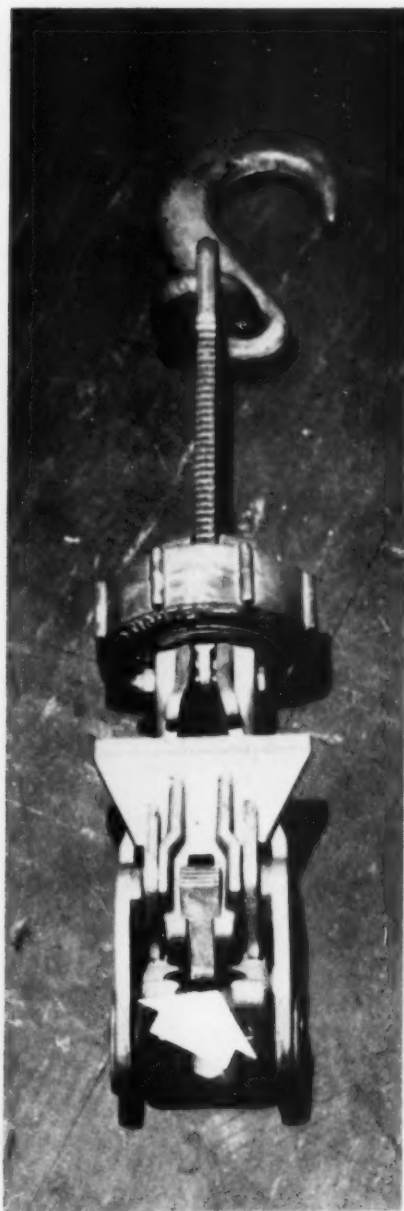
3

3. Butterfly retaining spring broken; butterfly can release chain without warning.

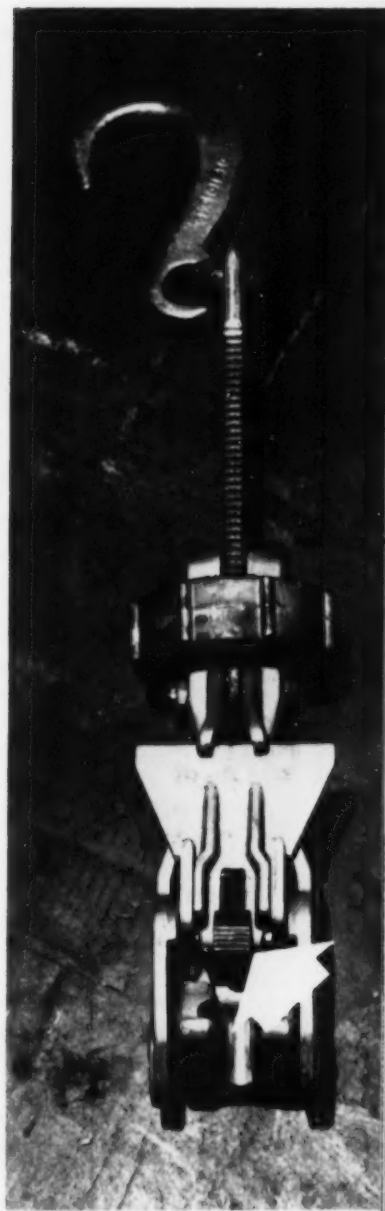
4

4. Locking pawl installed backwards during head repair (Murphy); same as not having pawl.

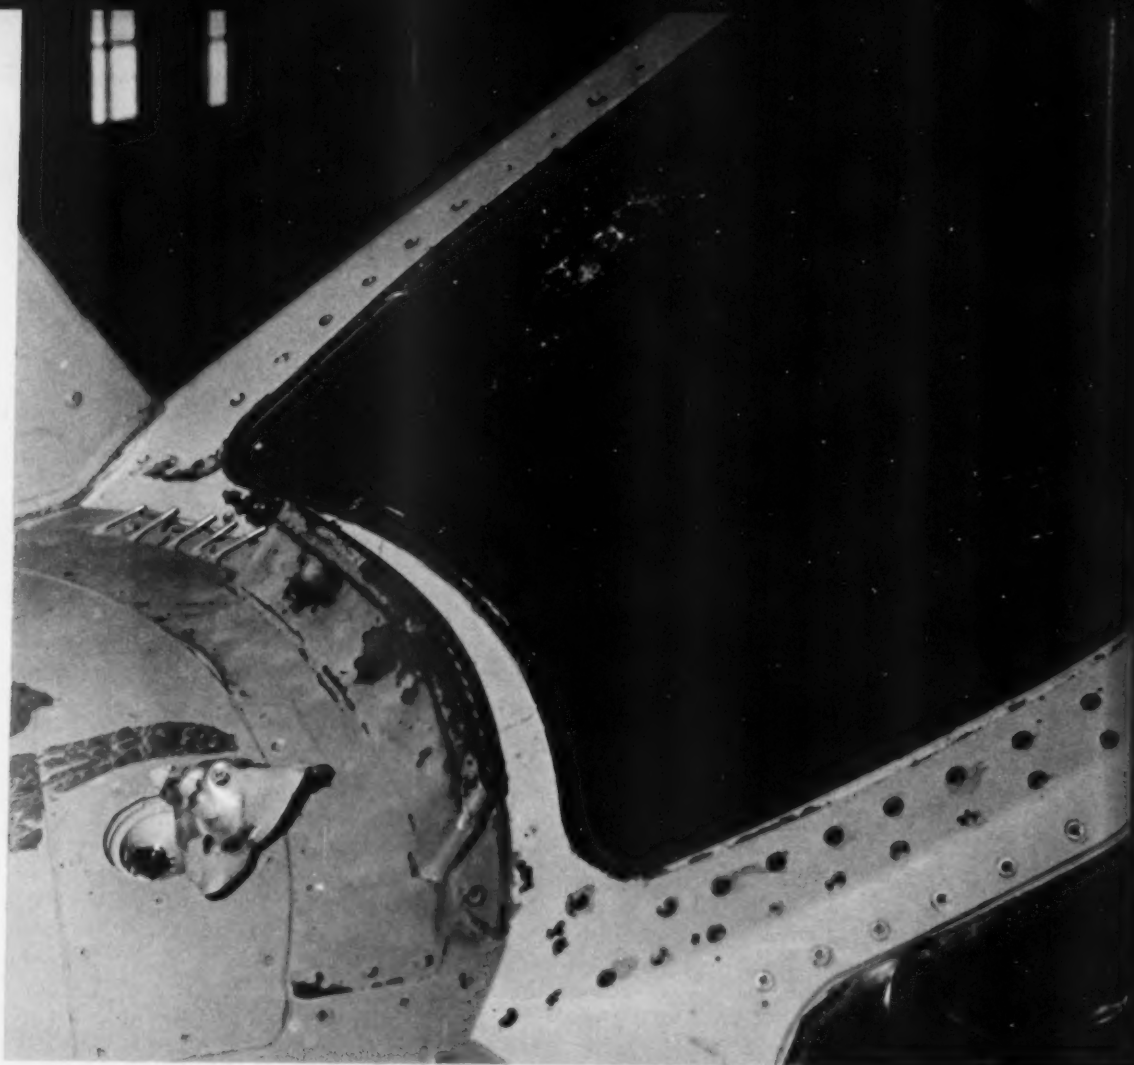
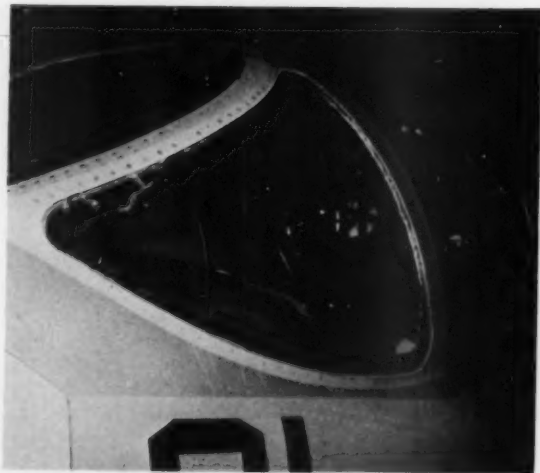
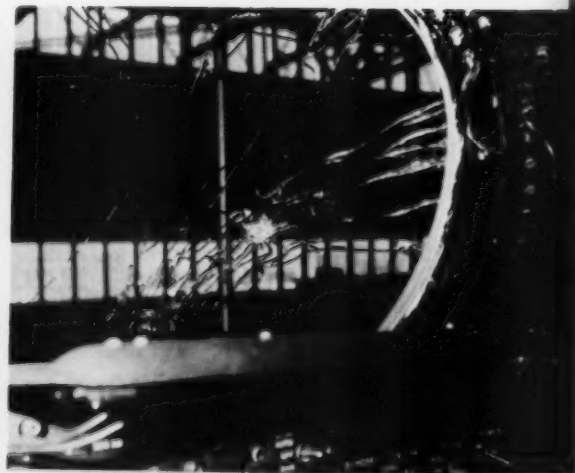
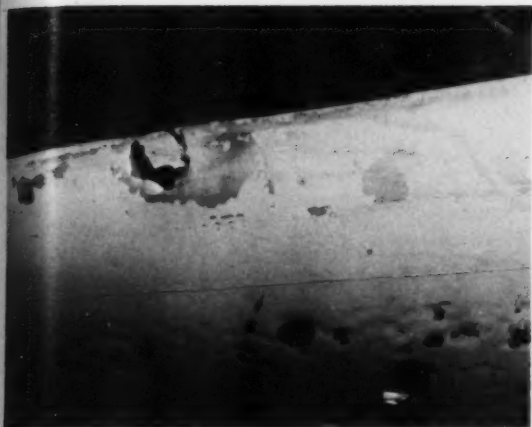
The damage sustained by this A-6 could easily have been caused by enemy ground fire or errant golf balls! Few aviators realize the destructive potential of hail found in thunderstorms until some event like this occurs. A little hail can go a long way towards spoiling your afternoon!

Although severely damaged, the aircraft handled well; yet ejection was a distinct possibility and thoughts of ejecting into a hailstorm gave added emphasis to the necessity of flying out of the cell. Just before the BN lost his search radar he reported that his 30-mile scope was covered with dense, stormy weather. The pilot noted that the leading edge of the port wing slat had many large holes and dents in it which caused him to distrust his AOA, since the probe could easily have been bent.

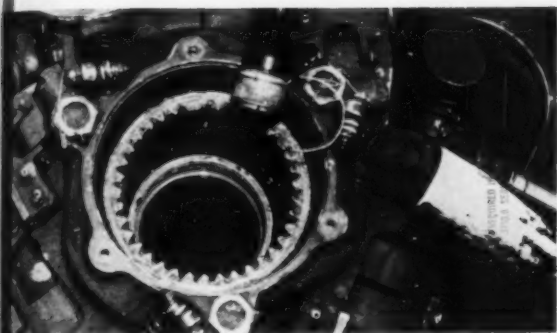
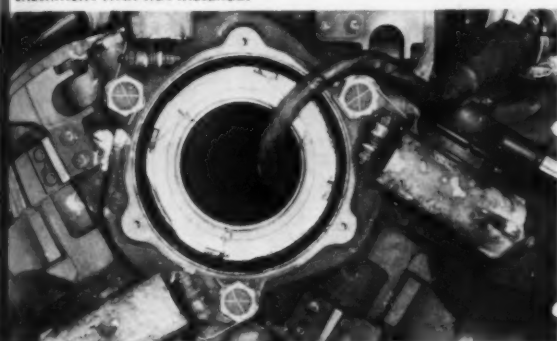
Photo above shows aft rotary wing head of the Queen, as found by AAR Board, with the attachment nut *not* installed, while the comparative photo below shows the rotary wing head attachment with nut installed.

with a severe vertical beat. After all, just how long can a lady go without TLC or sweet talk or attention? Any self-respecting gal, accustomed to the finer things of life, gets kind of mean when subjected to four months solitary. On the next test hop she again evidenced her stubbornness by a more than normal beat in a hover so she was landed and taxied back to the line. Fearing that she would be isolated once more and having decided that enough was enough she turned on such a temper tantrum that it was hard to believe. After docilely entering the chocks she planted both feet hard, threw her nose way up (the rear rotors hit the ground) and almost simultaneously the aft pylon began to collapse, the forward and aft blades intermeshed and debris was scattered in all directions. Her reign was ended.
